| ORIGINAL FILE COPY DTIC REPORT DOCUMENTATION PAGE | | | | |
|---|---|--|--|---|
| 6a. NAME OF PERFORMING ORGANIZATION Georgia Institute of Technology School of Aerospace Engineering | | 6b. OFFICE SYMBOL (If applicable) | 7a. NAME OF MONITORING ORGANIZATION Naval Research Laboratory | |
| 11. TITLE (Include Security Classification) Corrosion of Metals Exposed to Combustion Products Generated During | | | | |
| 12. PERSONAL AUTHOR(S) Shipboard Fires E. A. Powell, B. T. Zinn | | | | |

CORROSION OF METALS EXPOSED TO COMBUSTION PRODUCTS
GENERATED DURING SHIPBOARD FIRES

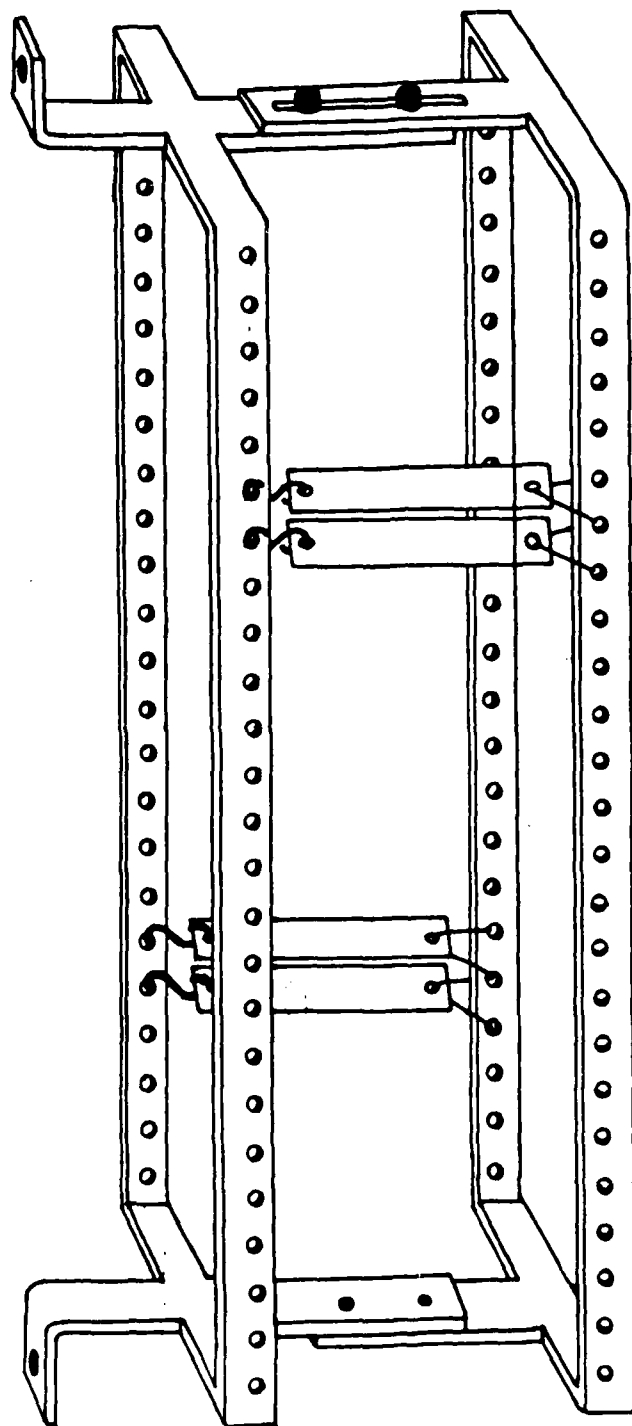
Figure 3. Test Specimen Rack.

The lower rack (Station 2) was located 79 cm (31 in) above the deck. Both racks were located 61 cm (24 in) out from the bulkhead. These locations were based on the results of earlier tests in the series which showed much more smoke at the higher levels in the fire compartment. A photograph of the test racks and specimens installed in the fire compartment just prior to a test is shown in Figure 4.

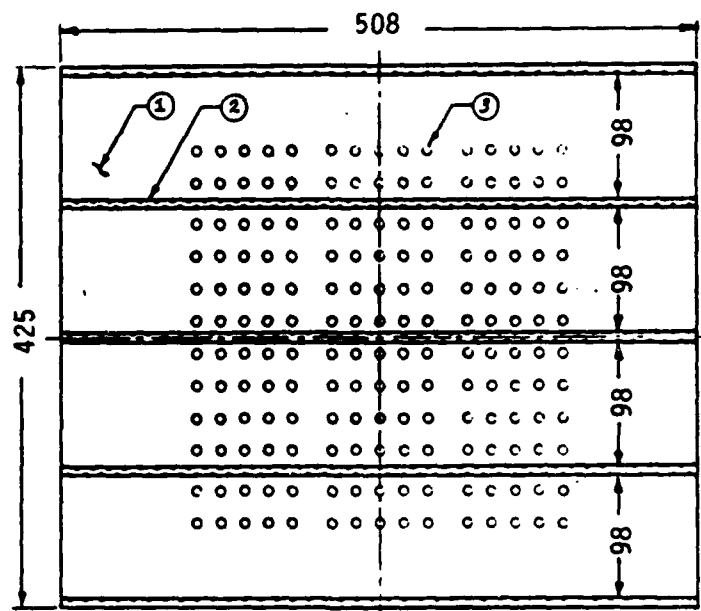
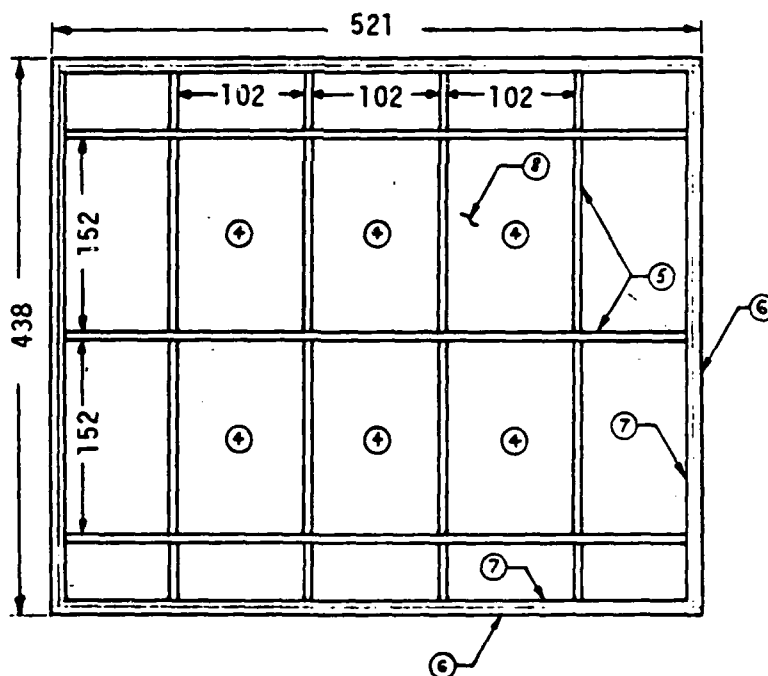
Figure 6. Schematic of Storage and Transport Case with Removable Specimen Tray.

Two storage cases were constructed, one for each test. Each case was a box 44 cm (17 1/4 in) wide, 52 cm (20 1/2 in) long, and 6.7 cm (2 5/8 in) deep fitted with a removable tray. The tray was partitioned lengthwise into four sections for storing the metal coupons. The partitions were provided with vertical slots for holding the coupons at the ends. The tray could hold up to 150 metal coupons, each separated from its neighbors by a 1.25 cm (1/2 in) gap. This arrangement protected the coupons with their adherent combustion products and corrosion products from contact with each other and from contamination from the environment.

The trays occupied the upper half of the storage boxes, while the lower half could be used for the storage of water soaked sponges to provide a high humidity environment for the coupons if desired. The bottom of the specimen tray was perforated with numerous 6.35 mm (1/4 in) diameter holes to allow the water saturated air in the lower compartment to reach the corrosion test specimens. However, direct contact of the test specimens with liquid water was prevented by this configuration. The test specimens were sealed from the

| 1. Perforated floor of tray | 5. Inner partitions, 25 mm high |
| 4. Sponge compartments | 8. Floor of case |

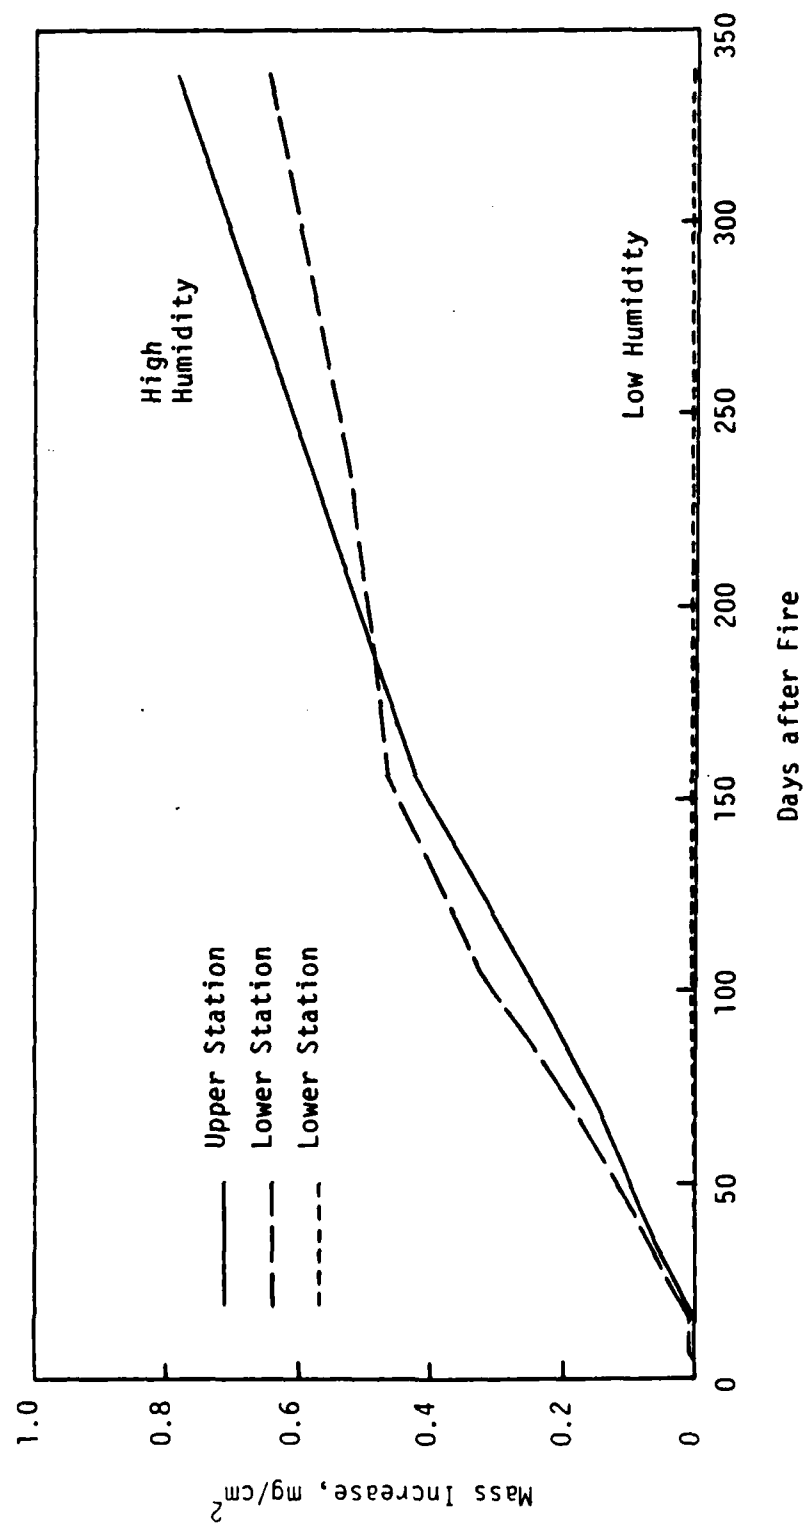
Figure 8. Mass Increases Due to Corrosion for HV80 Steel for Test W-11.

Gravimetric data for the HY80 steel specimens are presented in Figure 8, where the mass increase per unit area ($\Delta m/A$) is plotted versus elapsed time. These curves illustrate the drastic effect of ambient humidity upon the corrosion process. For the first 15 days after the fire test, while all specimens were at about 70% humidity, the mass increase was negligible. After the humidity was increased to nearly 100%, the specimens in the high humidity group increased steadily in mass, reaching $\Delta m/A$ of about 0.7 mg/cm^2 after about 320 days. The specimens in the low humidity group, which remained at 70% humidity, showed insignificant mass increases of only 0.01 mg/cm^2 during this period. The control specimen, which was also exposed to 100% humidity, increased in mass by only 0.14 mg/cm^2 during the same period. These curves show that the vertical location during the fire test had no significant effect on the ensuing corrosion, probably because the smoke density varied only slightly with height during this test.

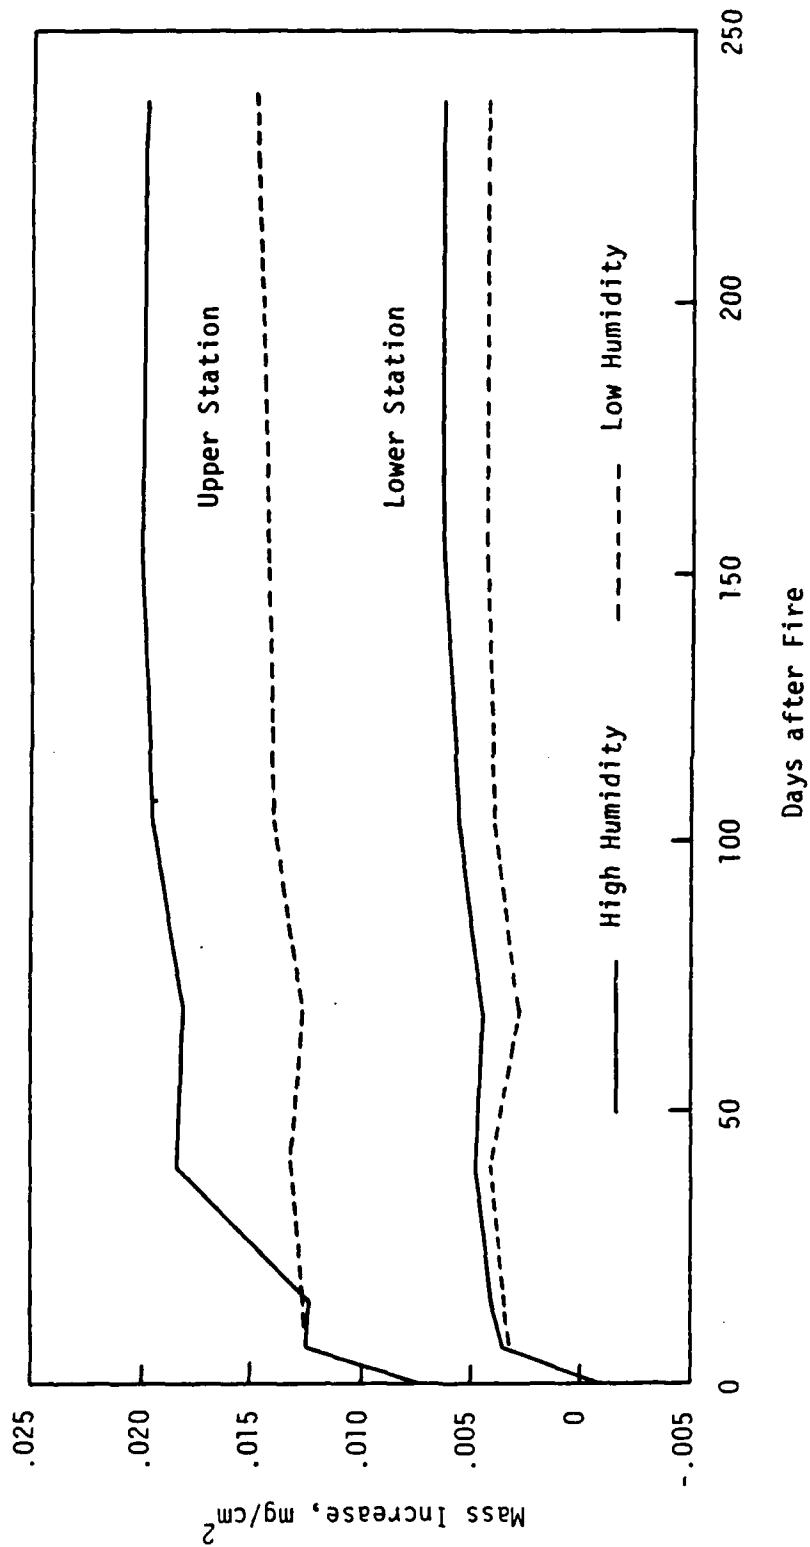
Figure 11. Mass Increases Due to Corrosion for Brass for Test W-11.

The mass increases for the brass specimens exposed to the combustion products generated in Test W-11 are presented in Figure 11. For both stations a mass increase of about $.005 \text{ mg/cm}^2$ occurred during the first week after the fire under 70% relative humidity, but little further mass increase occurred for the low humidity group during the remaining 230 days of the corrosion assessment period. The mass increases were only slightly greater for the specimens from the lower station which were stored at 100% humidity. During the first 25 days of the high humidity phase, the specimens from the upper station increased in mass by an additional $.006 \text{ mg/cm}^2$, but little further change occurred during the rest of the post-fire period. This initial mass increase in the 100% humidity environment probably resulted from the absorption of moisture by combustion products deposited on the surface of these specimens. The mass increases for the control specimen (100% humidity) were

all slightly less than those for the low humidity specimens from the lower station.

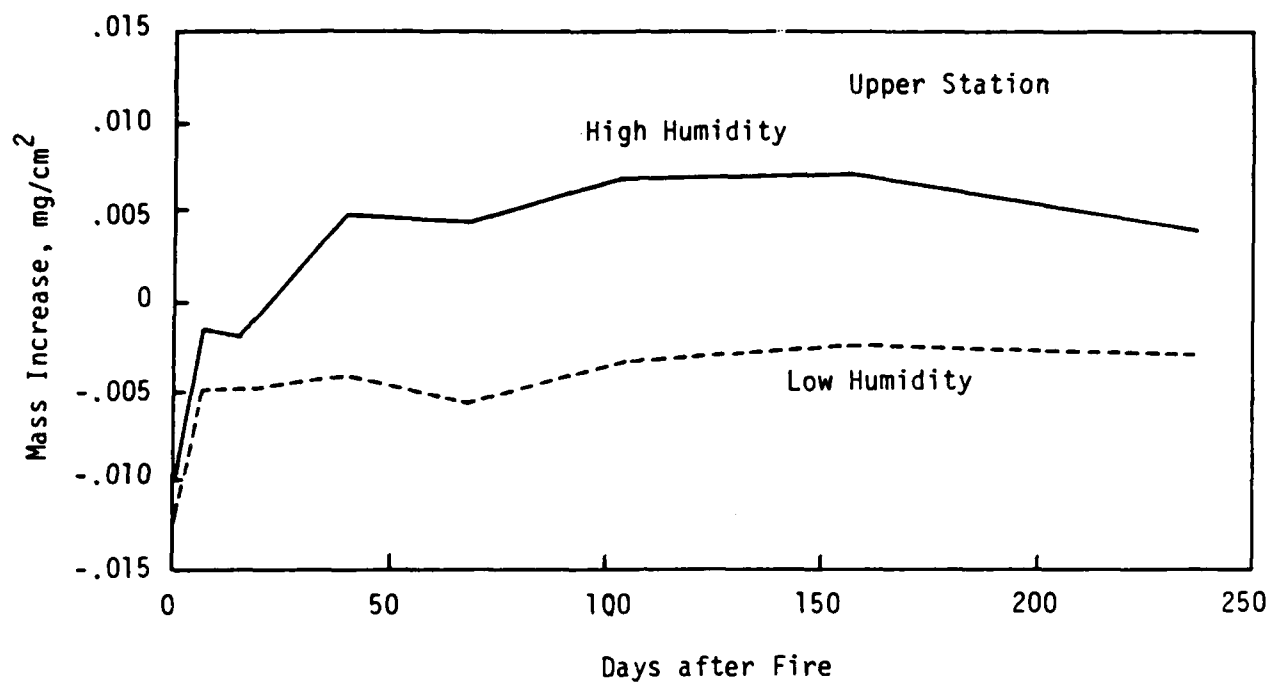
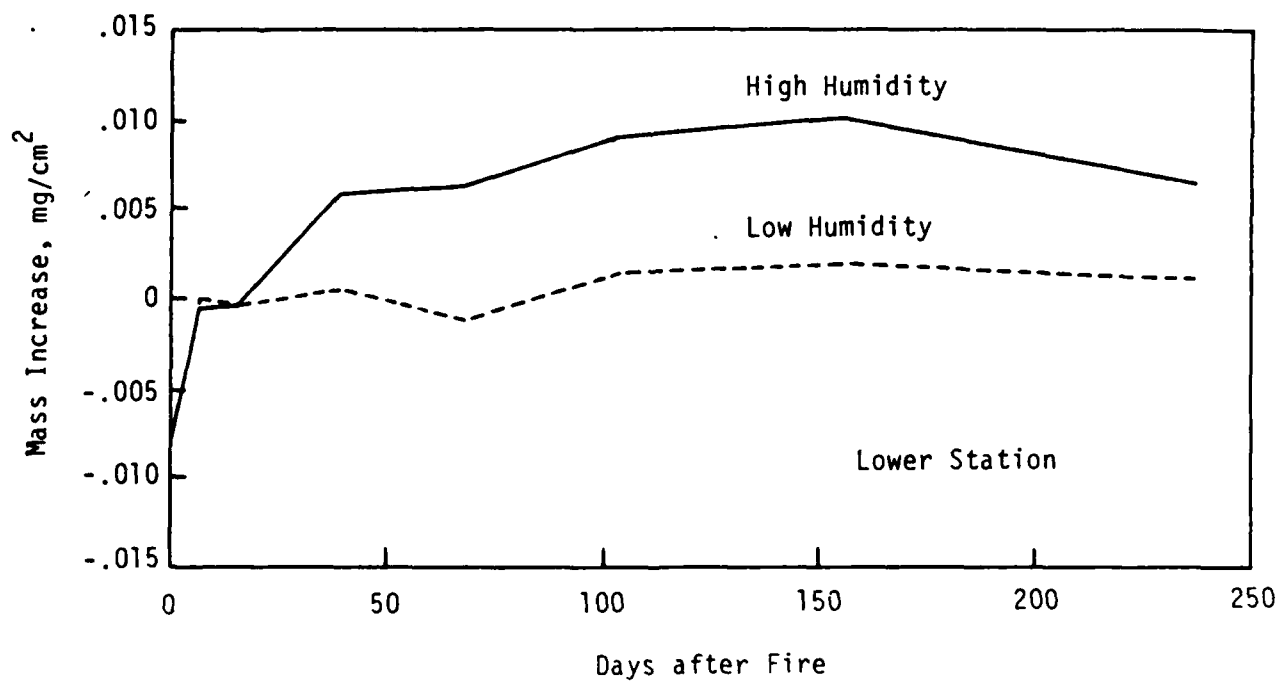
Figure 12. Mass Increases Due to Corrosion for Monel 400 for Test W-11.

The gravimetric data for the Monel 400 specimens exposed to the combustion products generated in Test W-11 are plotted in Figure 12. The specimens from both stations increased in mass by about 0.008 mg/cm^2 during the first week after the fire (70% humidity environment), and those which remained at low humidity exhibited much smaller additional mass increases during the remaining 230 days of the observation period. The specimens in the high humidity group gained an additional $.008 \text{ mg/cm}^2$ of mass during the first 25 days after the humidity was increased to 100%, but showed little further change in mass at the end of the post-fire period. As with the brass

specimens, the mass increases for the high humidity group of Monel 400 specimens are attributed to absorption of moisture by the deposited combustion products. The control specimen, which was also exposed to high humidity, exhibited mass changes similar to those of the low humidity specimens from the lower station. Examination of the Monel 400 specimens at the end of the post-fire assessment period revealed no visible evidence of corrosion.

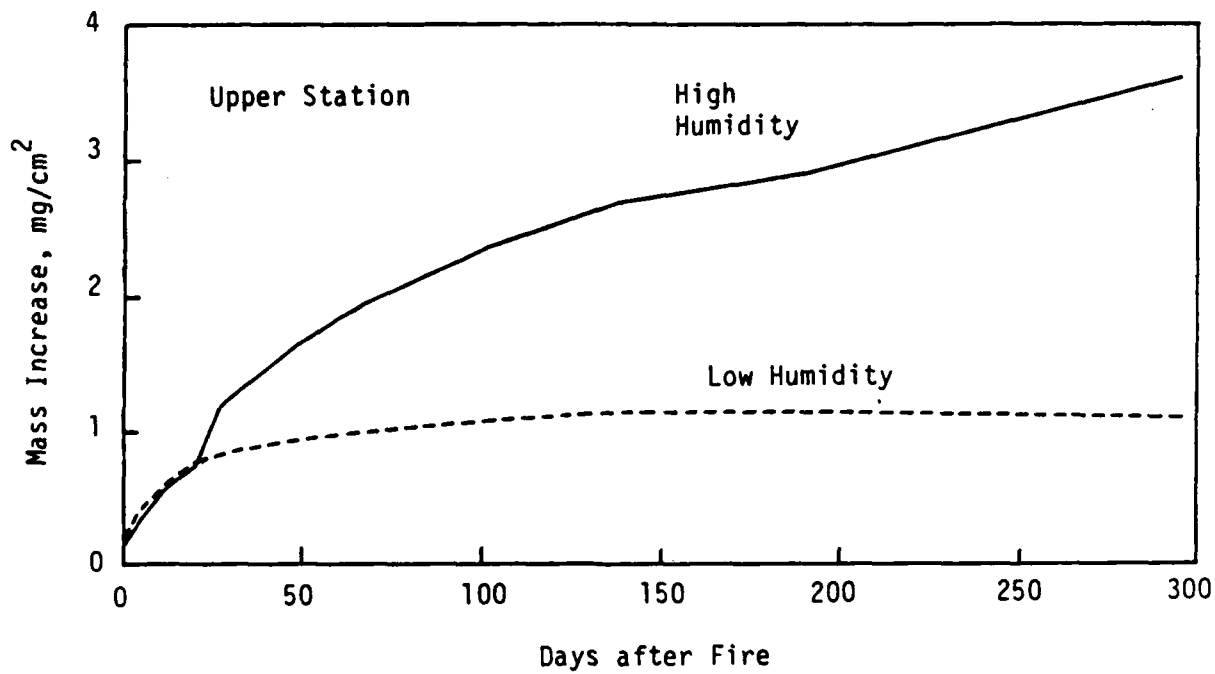
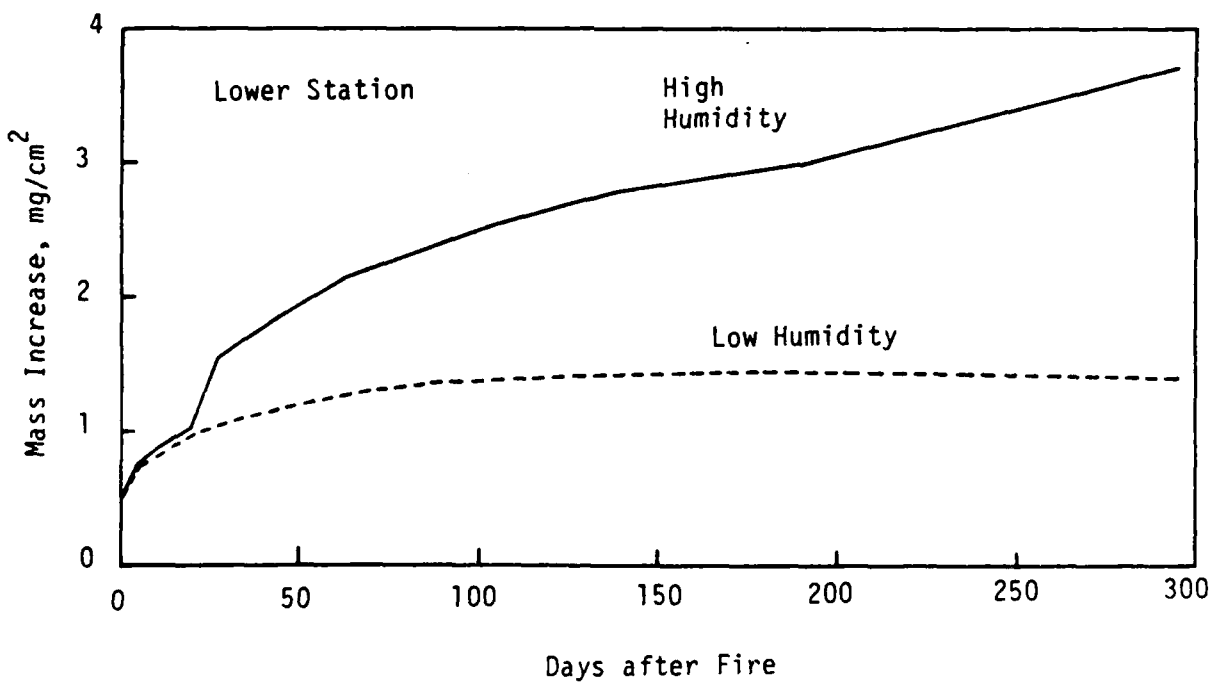
Figure 13. Mass Increases due to Corrosion for HY80 Steel for Test W-13 (Nonflaming).

(flaming). In Figures 13 and 15 the mass increase per unit surface area ($\Delta m/A$) is plotted versus elapsed time. This data includes the initial mass increases shown in Tables 5 and 6 as the values at time zero. Figures 14 and 16 display the average corrosion rates in mg/cm^2 per day during the time intervals between weighings, where the elapsed time for each plotted point is midway between the times for the corresponding weighings.

The curves of mass increase versus time for a given humidity group are qualitatively similar for both the W-13 (nonflaming) and the W-13A (flaming) specimens and for both upper and lower stations. For a given test and vertical location, however, these curves indicate the dramatic effect of ambient humidity in accelerating the corrosion process for HY80 steel. For example, consider the Test W-13A (flaming) specimens from the lower station (Figure 15, lower graph) for which the largest mass increases were obtained. During the first 20 days after the fire, when both humidity groups were at about 70% humidity, only modest mass increases (about 2.2 mg/cm^2) were obtained. After the humidity was increased to nearly 100%, the specimens in the high humidity group increased steadily in mass, reaching $\Delta m/A$ in excess of 16 mg/cm^2 at the end of the corrosion assessment period. The specimens in the low humidity group, which remained at 70% humidity, showed very little additional increase in mass, reaching $\Delta m/A$ of only about 3 mg/cm^2 . The control specimen, which was also exposed to 100% humidity, increased in mass by only about 0.3 mg/cm^2 during the same period. The specimens from the upper station for Test W-13A (Figure 15, upper graph) exhibited slightly lower mass increases due to corrosion than those from the lower station, in spite of the much greater smoke density which prevailed at the upper station during Test W-13A. The W-13 specimens, which were exposed only to the products of smoldering

combustion, experienced much smaller mass increases than the corresponding W-13A specimens (Figure 13). These $\Delta m/A$ values ranged from about 22% (high humidity) to about 42% (low humidity) of the corresponding values for Test W-13A. For the W-13 specimens the effect of vertical location upon the mass increases due to corrosion was also insignificant.

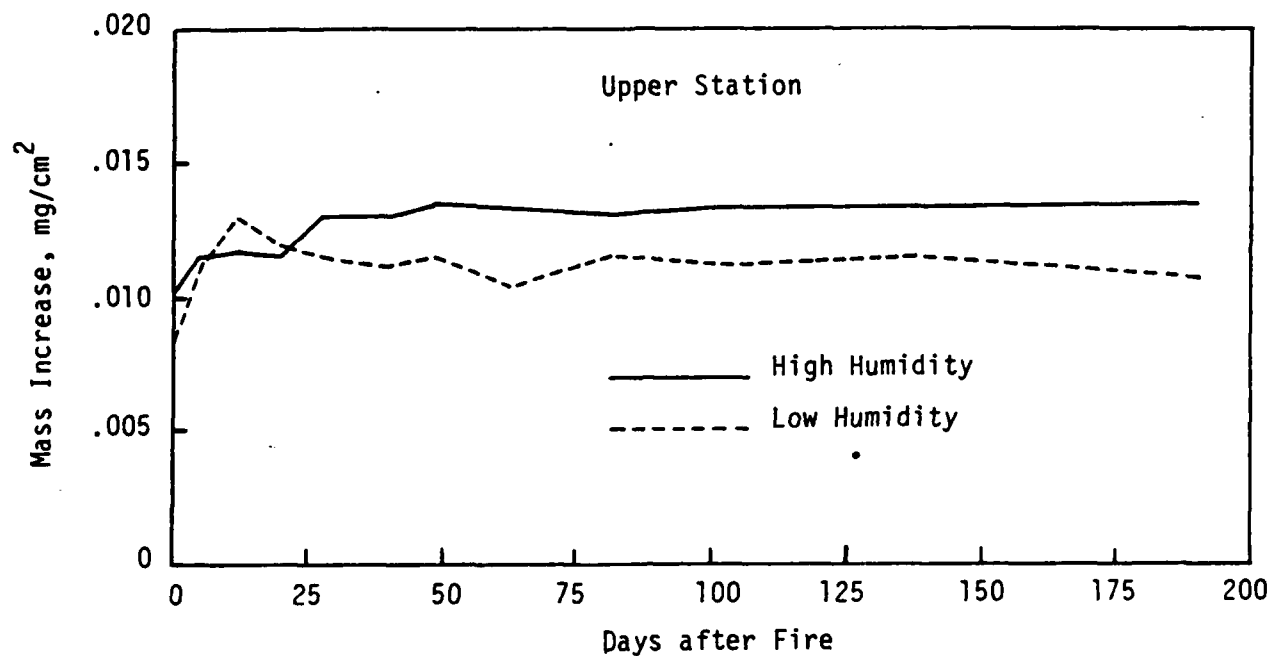
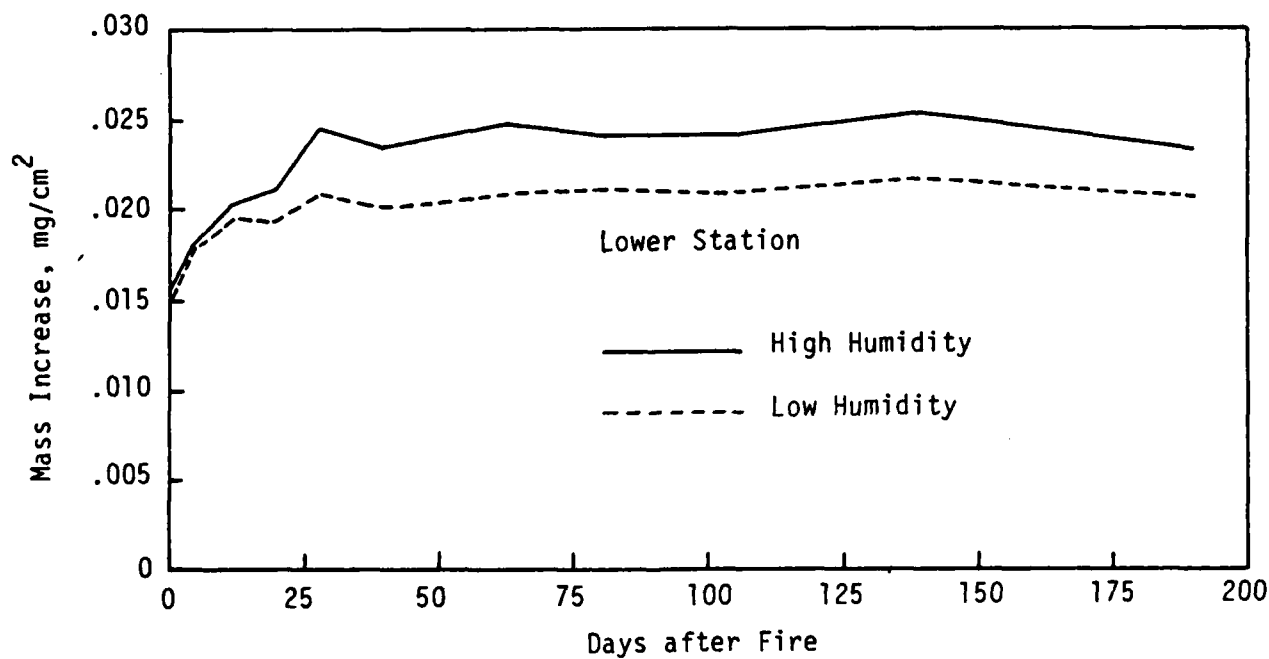
Figure 19. Mass Increases due to Corrosion for Type 304 Stainless Steel for Test W-13 (Nonflaming).

The gravimetric data for the type 304 stainless steel specimens are shown in Figures 19 and 20. For the specimens exposed only to the smoke generated by nonflaming combustion (W-13), Figure 19 shows very little mass increase beyond that due to deposition of combustion products during the fire test. Most of this additional mass increase occurred during the first 30 days after the fire test, with very little change in mass thereafter. Since this post-fire mass increase was significantly larger for the high humidity group, and the specimens showed little or no visible corrosion, it is suspected that the mass increase was due to water adsorption rather than to corrosion. For the W-13A specimens (flaming), Figure 20 shows that the mass of these specimens remained essentially constant during the post-fire period of 190 days, regardless of humidity or vertical location. The small differences between the high and low humidity groups are due to variations in the amount of smoke particulates deposited on these specimens during the fire test. The control specimen increased in mass by only 0.002 mg/cm² during the post-fire period.

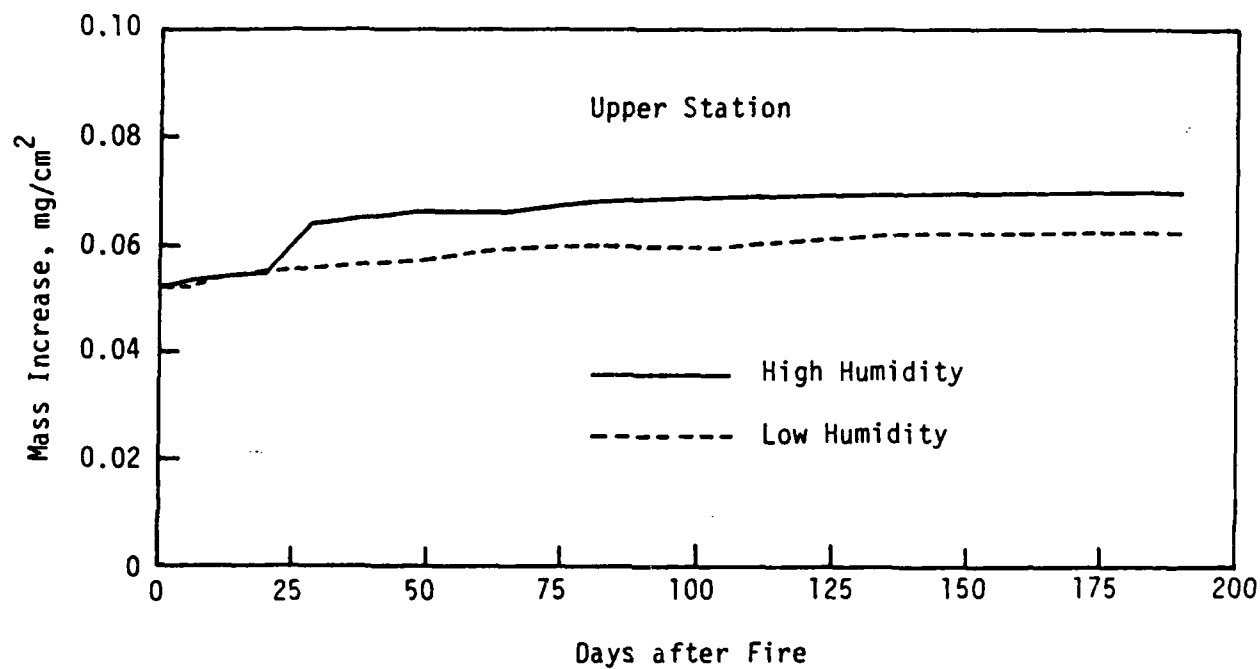
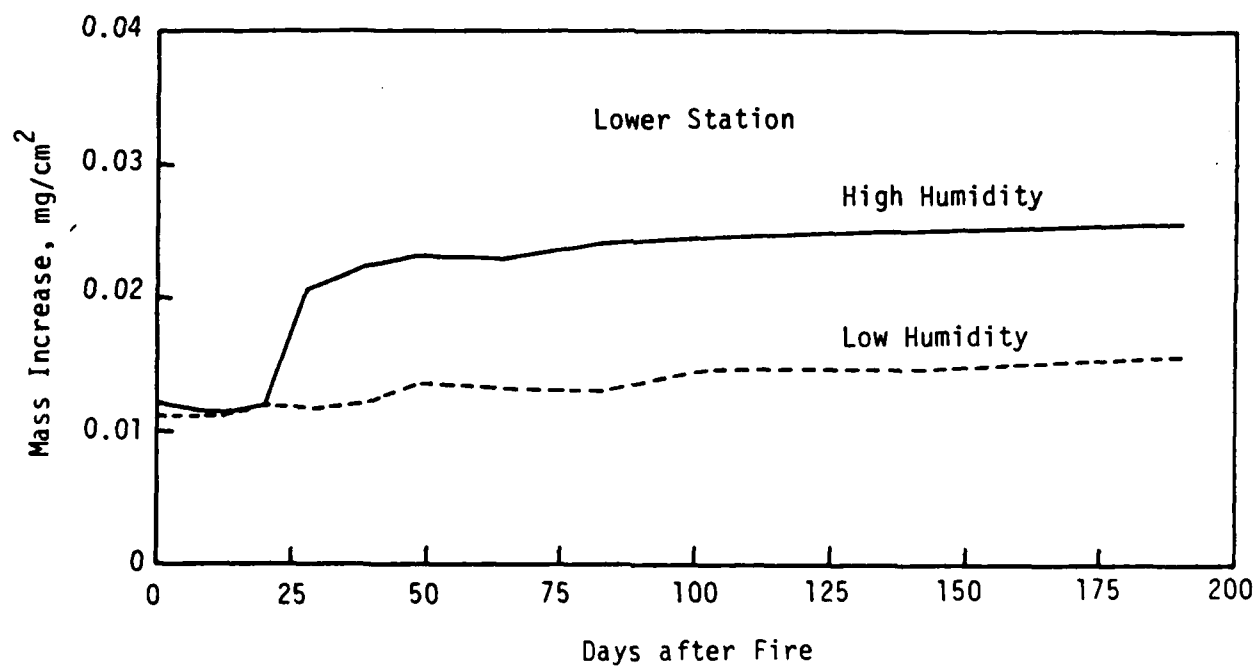
Figure 22. Mass Increases due to Corrosion for Brass for Test W-13 (Nonflaming).

The gravimetric data for the brass specimens are presented in Figures 22 and 23. For the W-13 specimens (nonflaming) in the low humidity group, Figure 22 shows that a slow steady increase in mass occurred during the post-fire period, but that this mass increase was small compared to the initial mass increase incurred during the fire. For the specimens in the high humidity group, an additional rapid mass increase occurred during the first eight days of the high humidity phase with very little further mass increase afterwards. As in the case of stainless steel, this increase in mass with the onset of high humidity was probably due to water adsorption. The amount of adsorbed water was about $.01 \text{ mg/cm}^2$ regardless of the vertical location of the specimens. Figure 23 shows a similar behavior for the W-13A (flaming) specimens from the lower station, with a much larger water adsorption of about 0.12

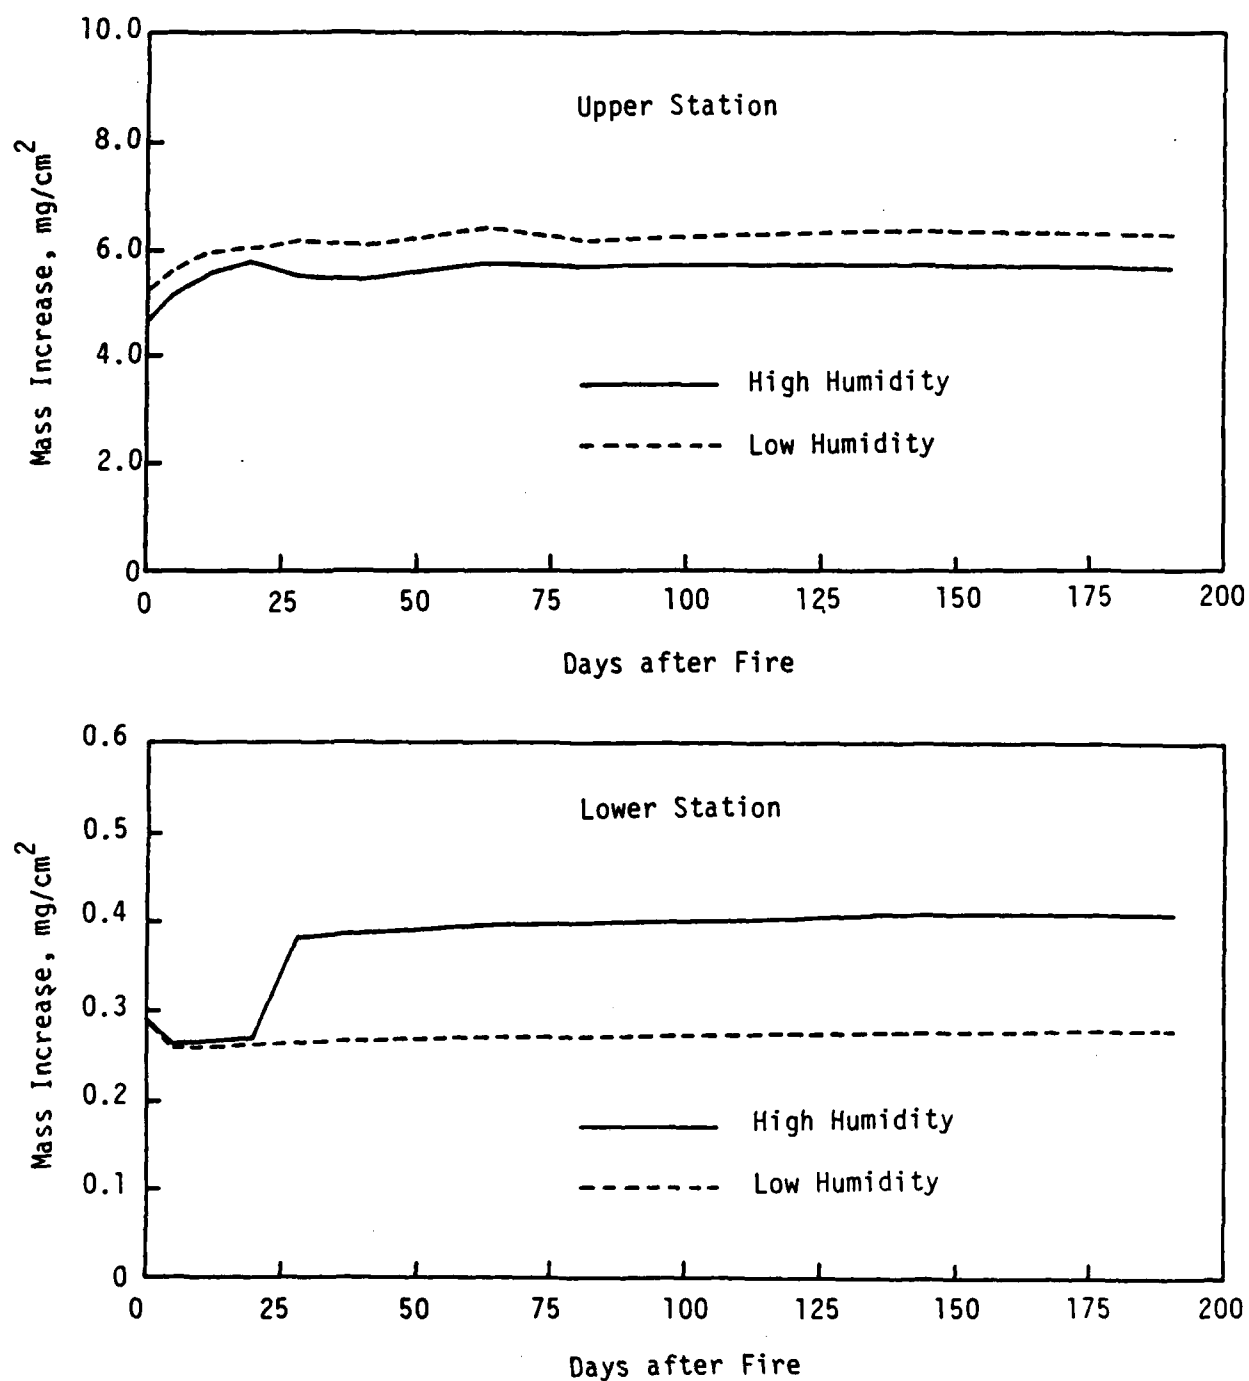
Figure 23. Mass Increases due to Corrosion for Brass for Test W-13A (Flaming).

mg/cm² during the early days of the high humidity phase. Here the water adsorbed is about 50% of the mass of the deposited combustion products. For the W-13A specimens of the upper station a large amount of water was adsorbed during the fire test (nearly 5 mg/cm²), and very little, if any, additional water was adsorbed during the high humidity phase, although additional mass increases of about 20% occurred during the first 20 days after the fire when both groups were at 70% humidity. The control specimen increased in mass by only 0.003 mg/cm² during the post-fire period.

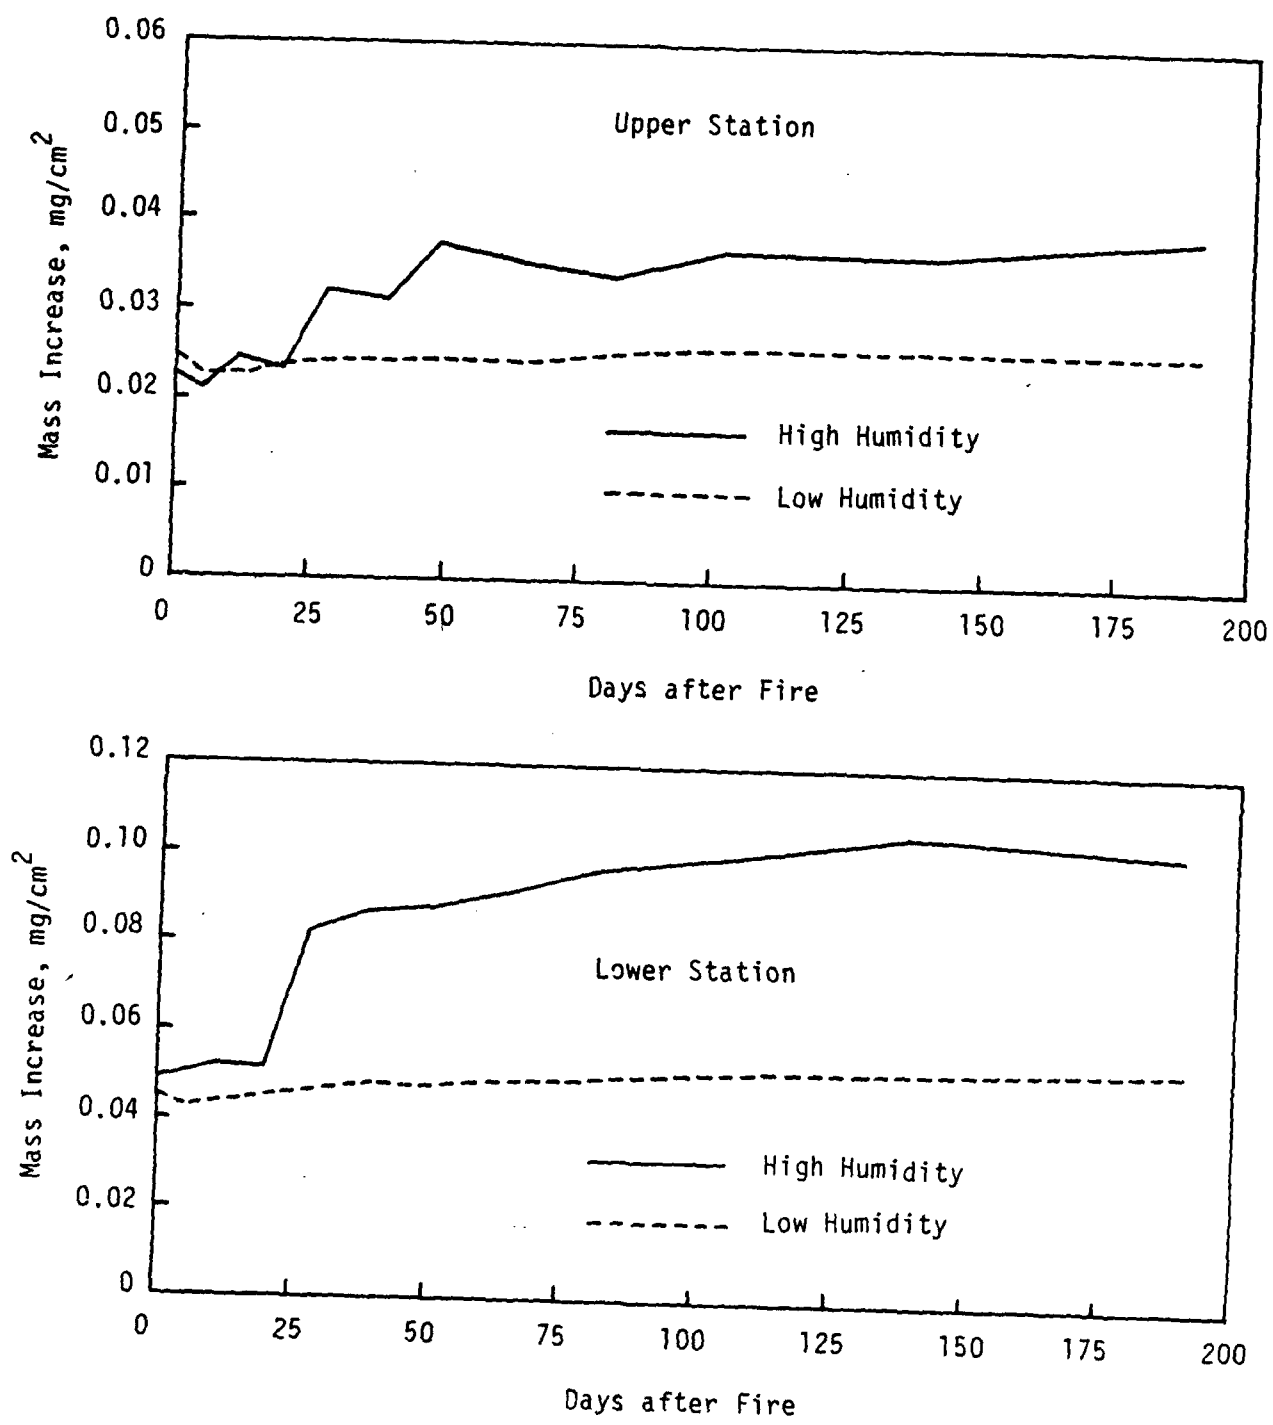
Figure 25. Mass Increases due to Corrosion for Monel 400 for Test W-13 (Nonflaming).

The mass increases during the post-fire period for the Monel 400 specimens are shown in Figures 25 and 26. For the low humidity W-13 specimens (nonflaming), Figure 25 shows only a very small increase in mass (less than 0.01 mg/cm^2) beyond that incurred during the fire due to deposition of combustion products. For the high humidity specimens from the lower station, an

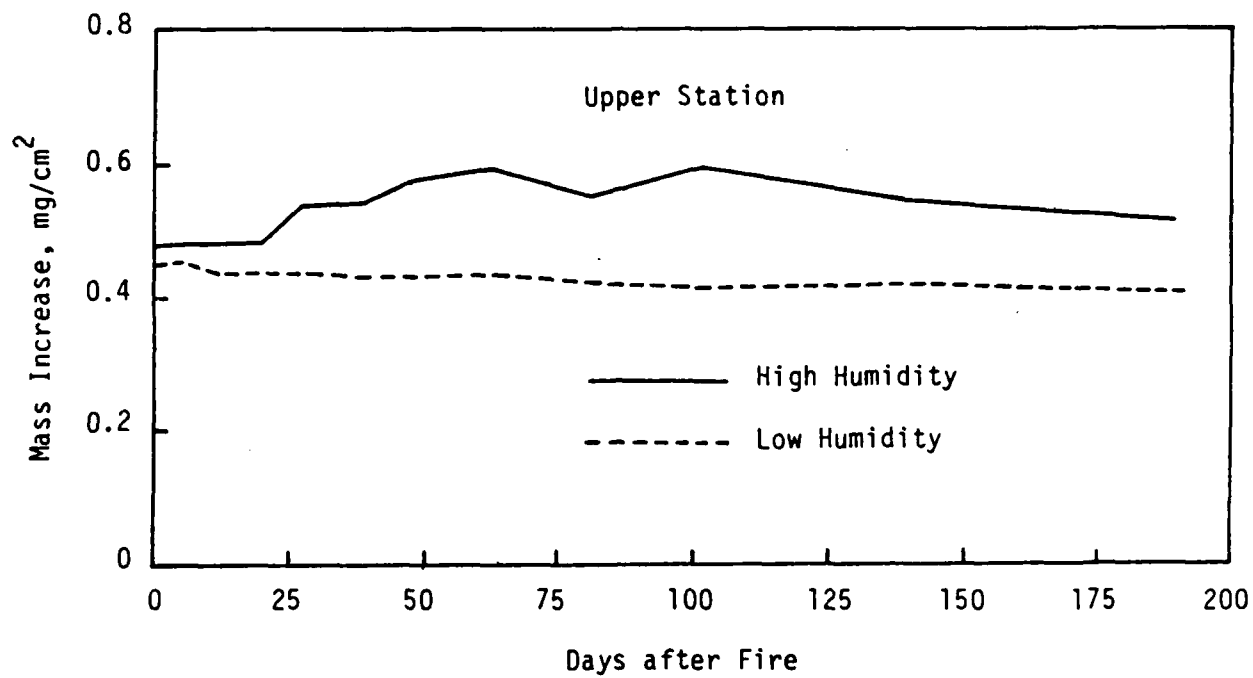
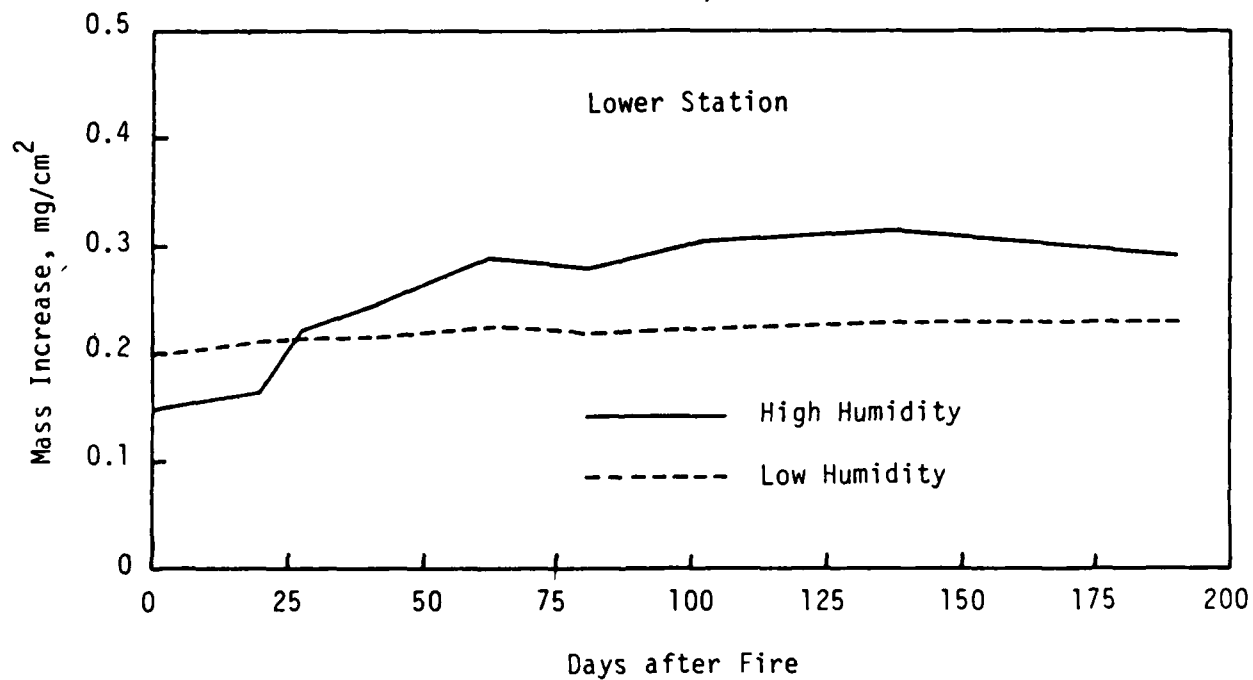
Figure 26. Mass Increases due to Corrosion for Monel 400 for Test W-13A (Flaming).

additional increase in mass of about 0.03 mg/cm^2 occurred during the first 8 days at 100% humidity followed by a more gradual increase in mass thereafter. For the corresponding specimens from the upper station, a more gradual mass increase of about 0.01 mg/cm^2 was observed. These mass increases incurred during the high humidity phase are again probably due to moisture adsorption by surface deposits. The gravimetric data for the W-13A (flaming) specimens are shown in Figure 26. For the low humidity specimens, little change in mass occurred during the post-fire period. The gradual mass decrease of 0.05 mg/cm^2 experienced by the specimens from the upper station can probably be attributed to losses of loosely adhering surface deposits during handling and weighing of these specimens. The gradual increase in mass of about 0.03 mg/cm^2 for the lower station specimens, however, is likely due to corrosion which is clearly visible on these specimens. For the specimens of the high humidity group, additional gradual mass increases of about 0.13 mg/cm^2 were observed during the initial half of the high humidity period. The control specimen, which was also exposed to high humidity, increased in mass by about 0.03 mg/cm^2 during the post-fire period.
